# **Revision Guide for AMD Family 15h Models 00h-0Fh Processors**

| Publication # <b>48063</b> | Revision: <b>3.16</b> |
| Issue Date: <b>August 2012</b> | |

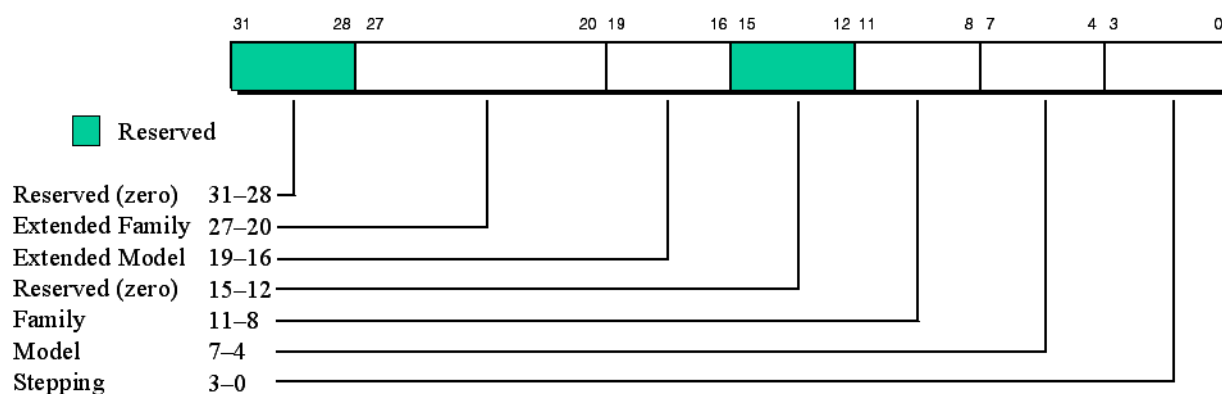
**Figure 1. Format of CPUID Fn0000\_0001\_EAX**

A processor revision is identified using a unique value that is returned in the EAX register after executing the CPUID instruction function 0000\_0001h (CPUID Fn0000\_0001\_EAX). [Figure 1](#) shows the format of the value from CPUID Fn0000\_0001\_EAX. In some cases, two or more processor revisions may exist within a stepping of a processor family and are identified by a unique value in D18F4x164 Fixed Errata Register (see [D18F4x164 Fixed Errata Register](#)).
